The Southall Rail Accident Inquiry Report

Professor John Uff QC FREng

Inquiry into Southall Railway Accident

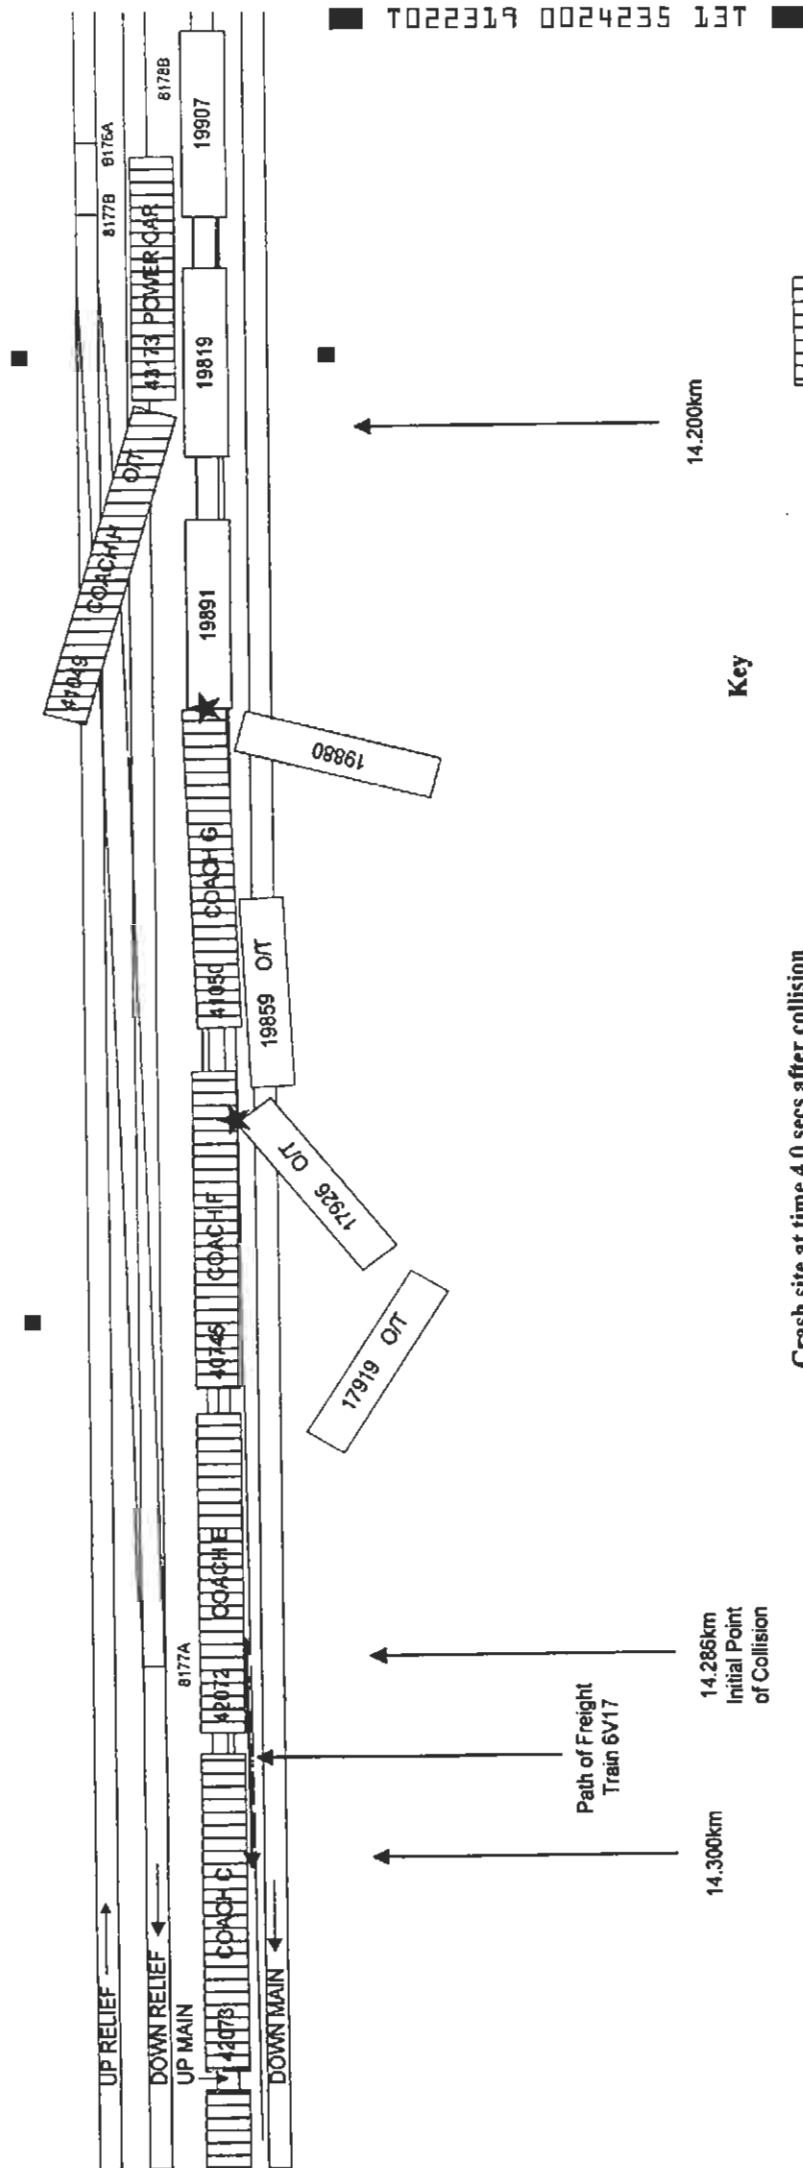
Crash site at time 4.0 secs after collision
Coach G and wagon 19891 collide then rise-up and jack-knife. The wagon tears out the front half of the side of coach G. Wagon 17926 penetrates the side of coach F.

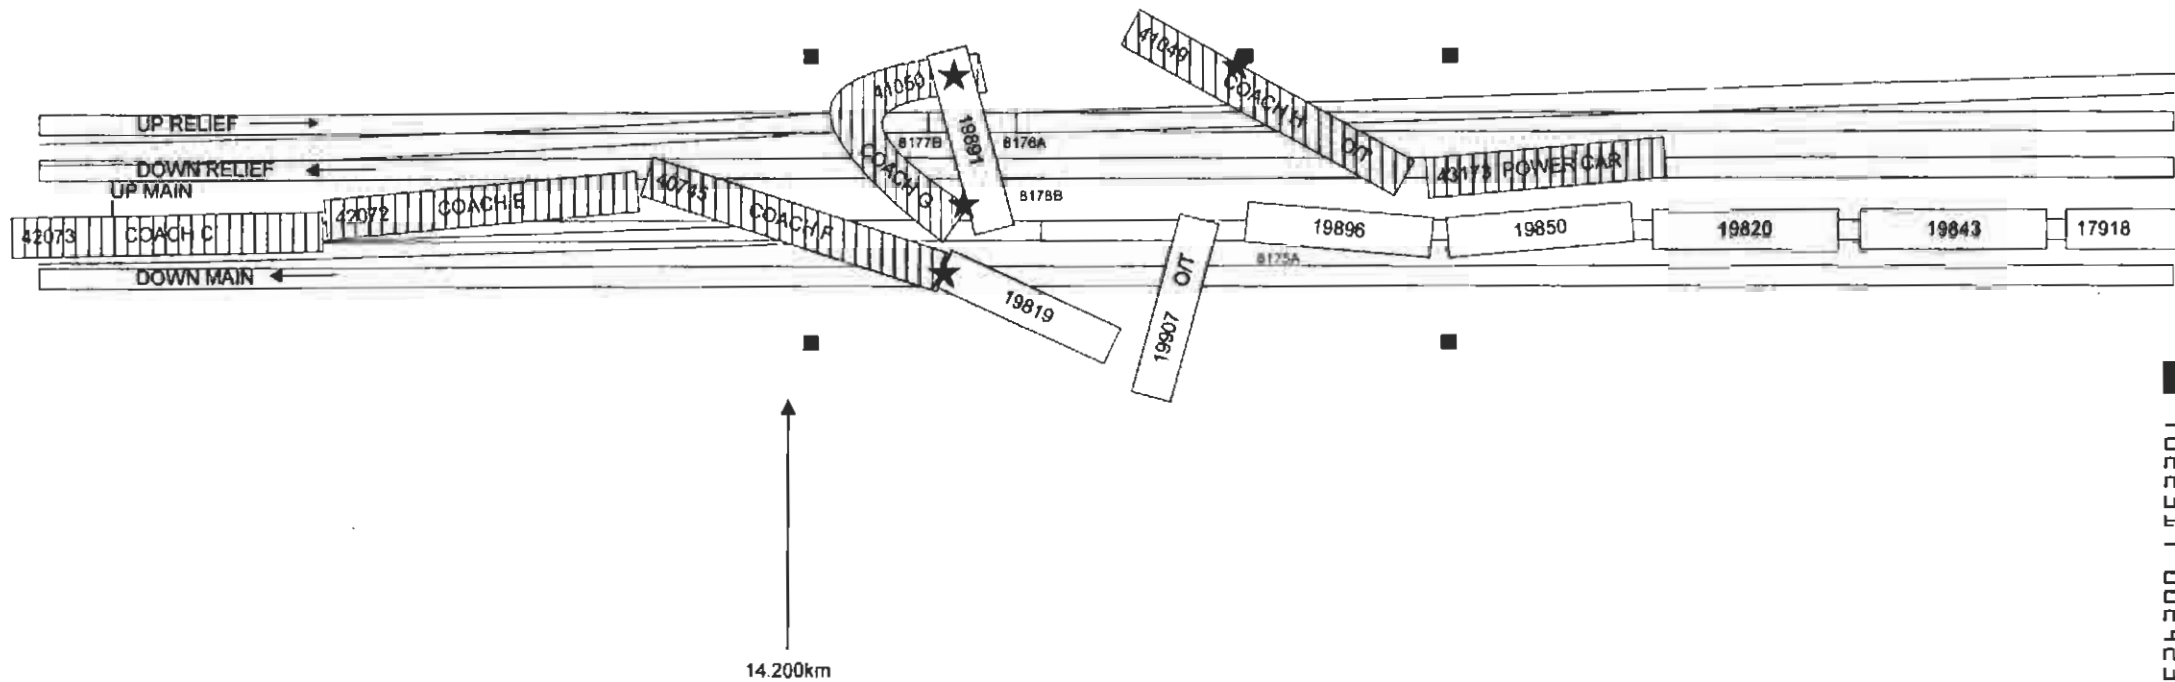
Crash site at time 8.5 secs after collision

Coach F impacts with Coach G which bends, allowing F to pass, colliding with wagon 19819.

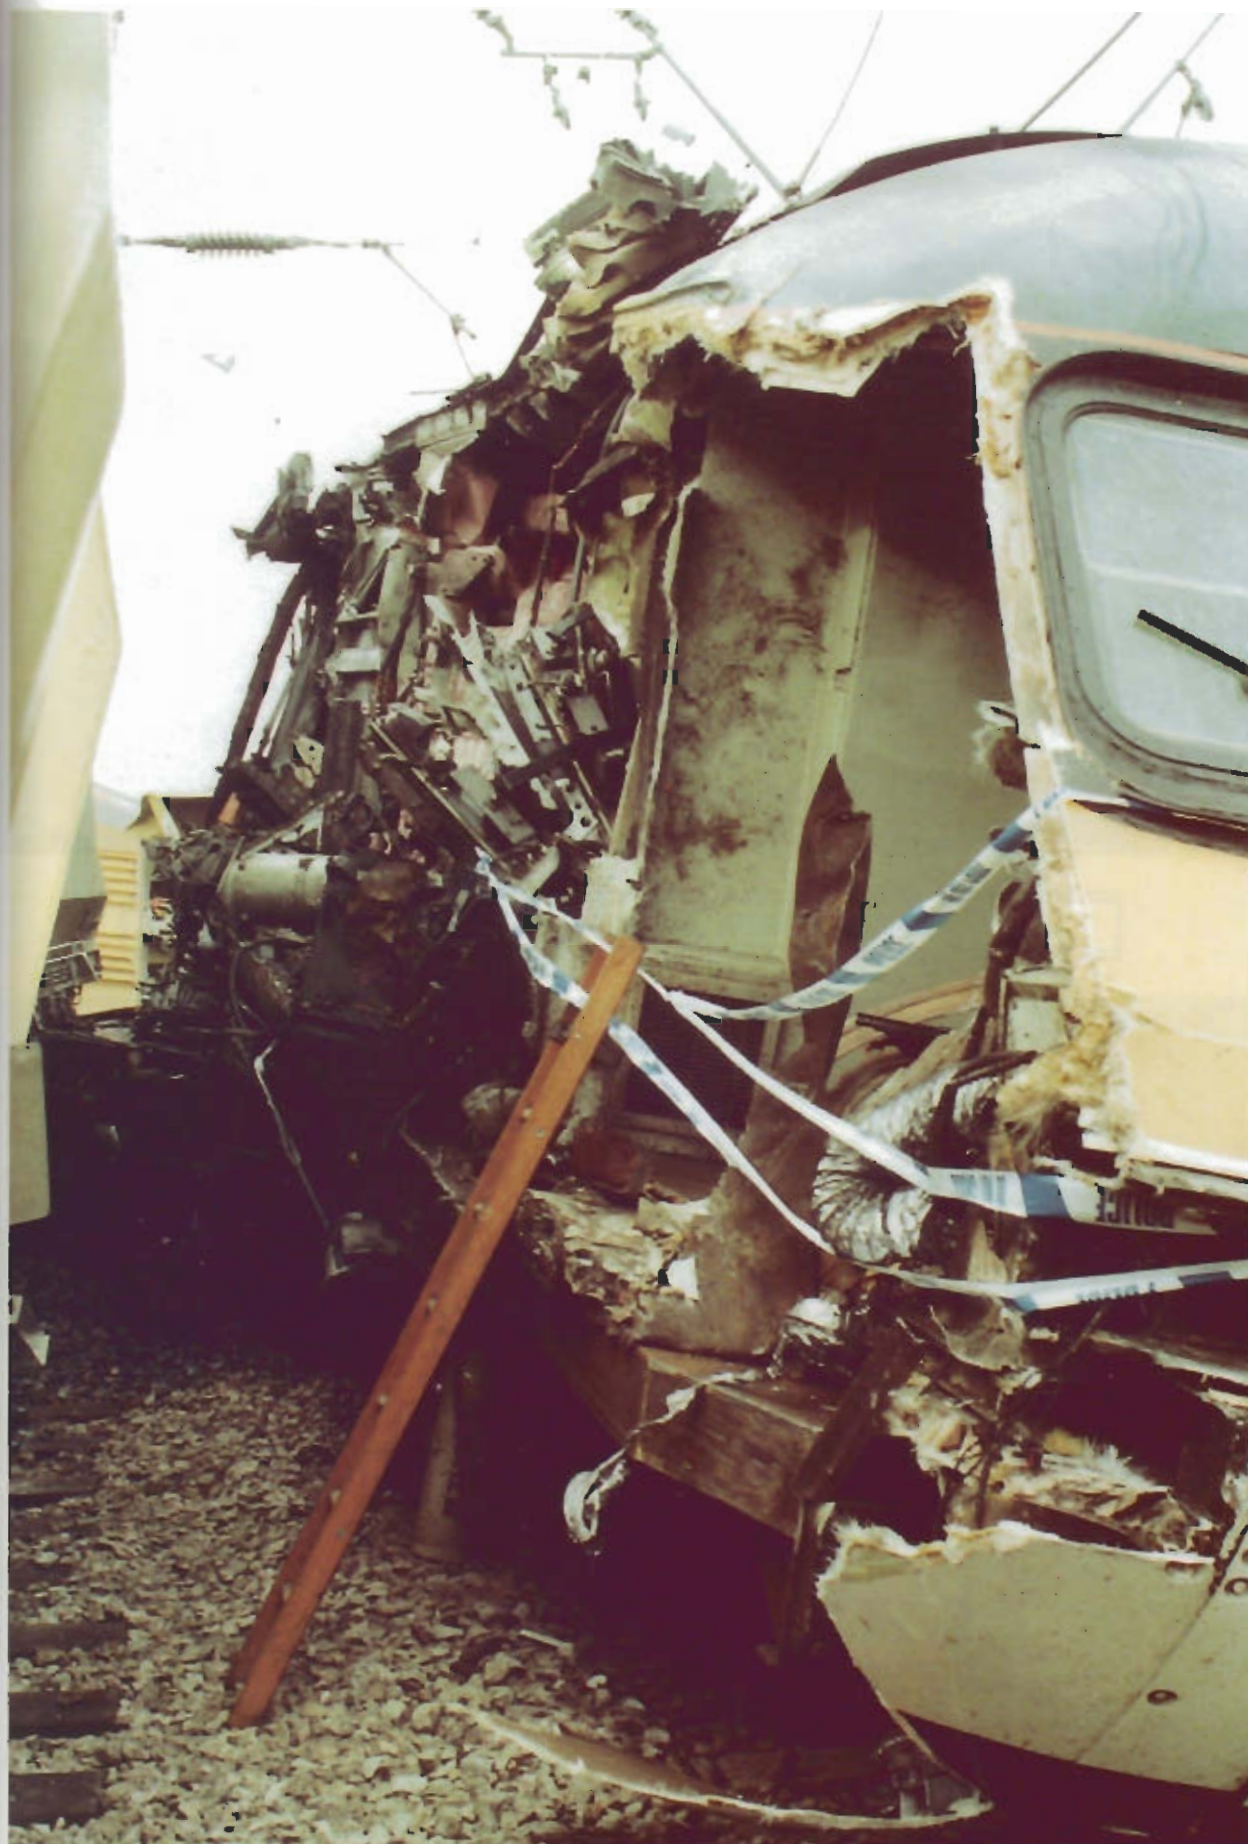
Damage to Power Car 43173 (Right Hand Side)

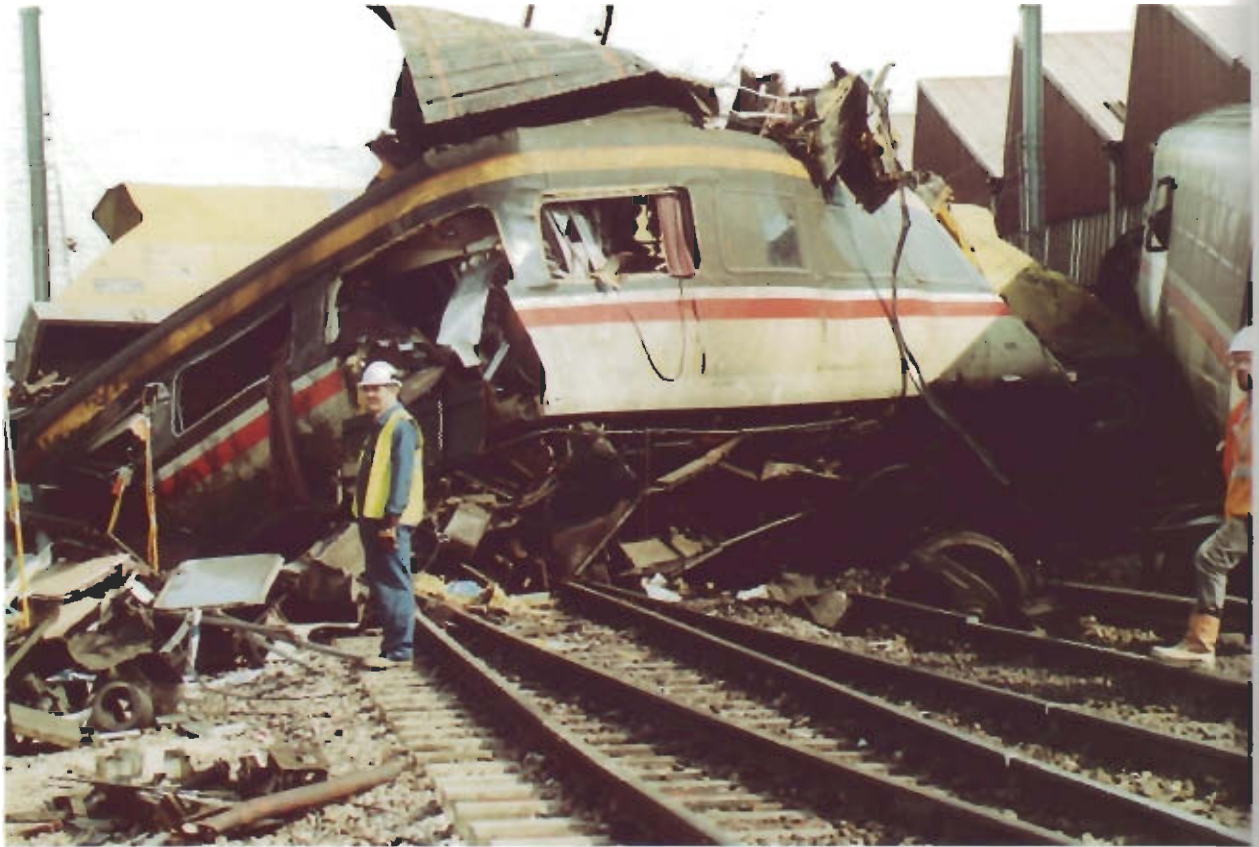
Damage to Coach G (main picture) and to Coach F (RHS)

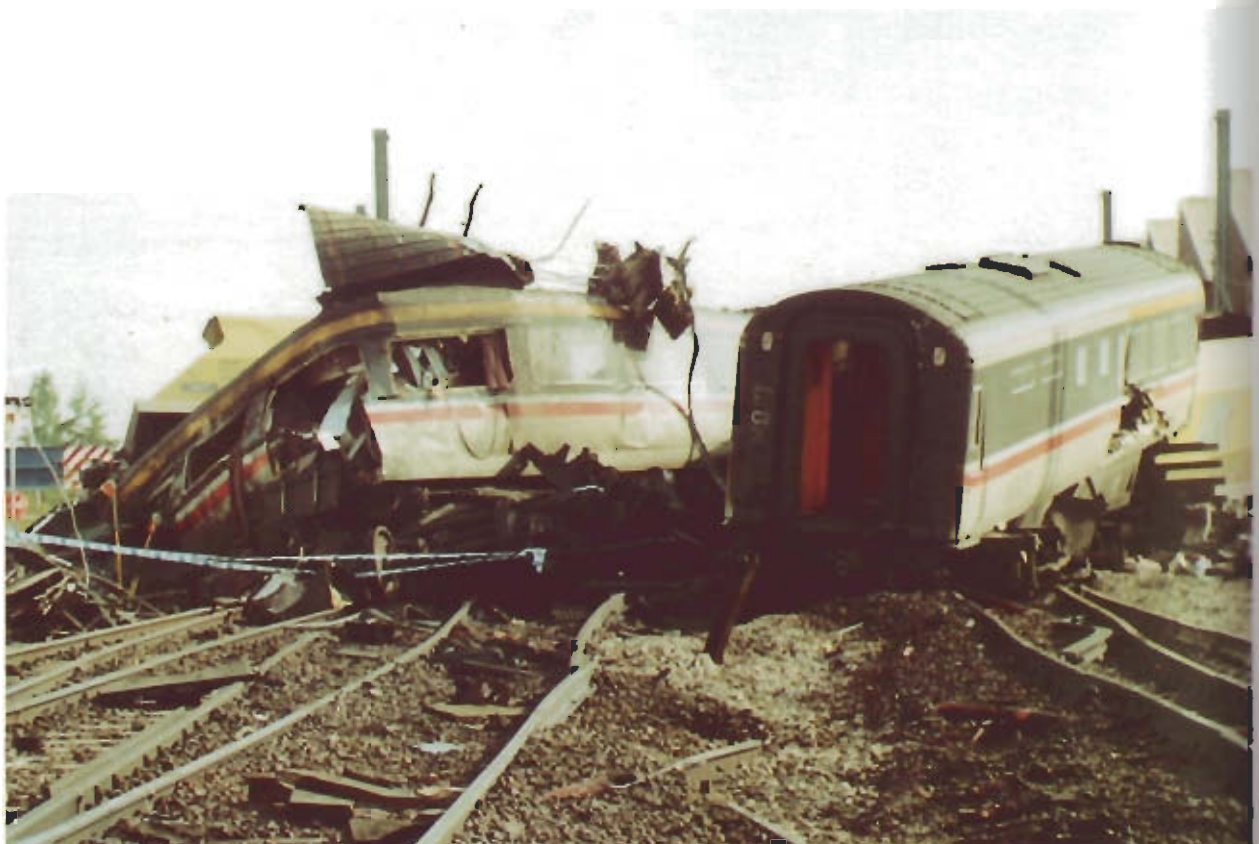
Damage to Coach G with Freight Wagon Coupler to left of picture / Coach F to the right

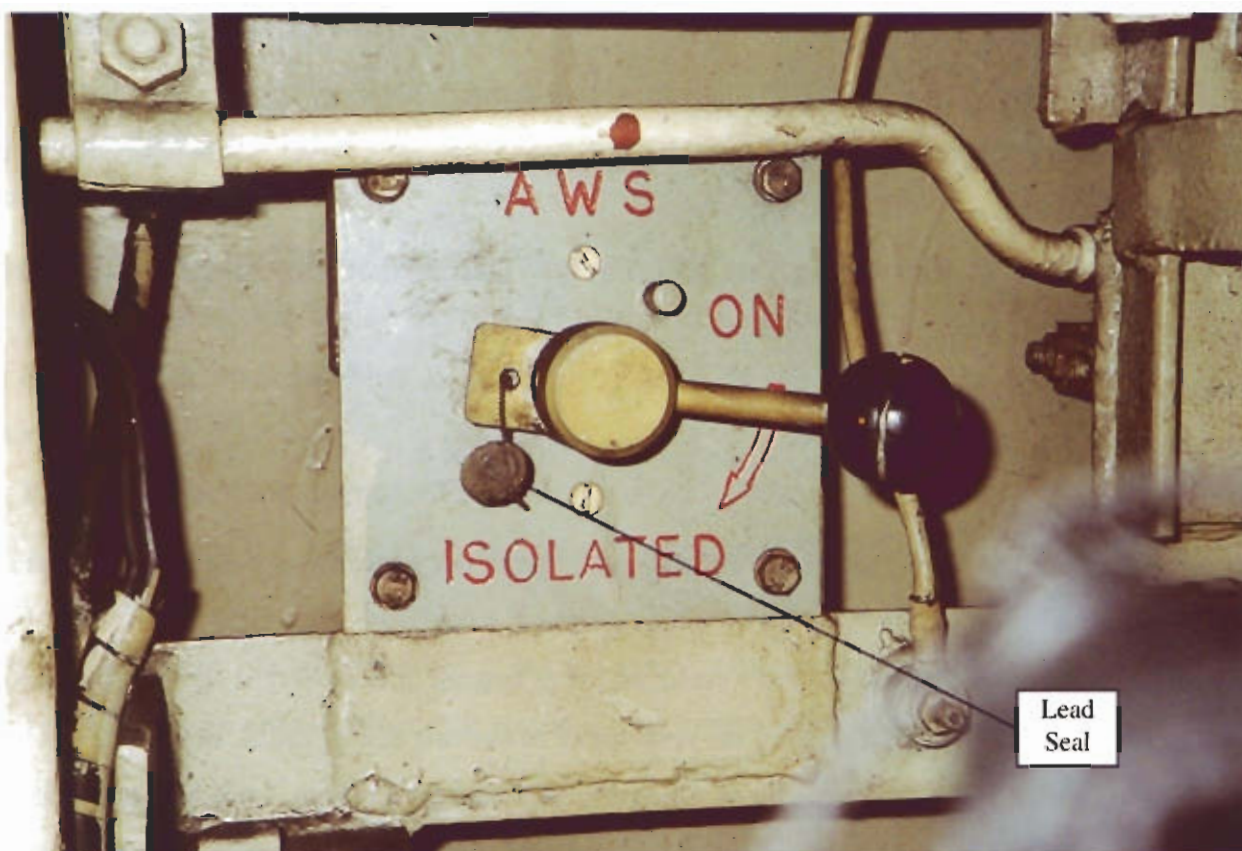
- 1.4 The second fault was more serious and had safety implications. The Automatic Warning System (AWS) in power car 43173 was not operational. It had been "isolated" by Driver Tunnock at Paddington Station after he brought the set from the depot at Old Oak Common. The AWS had operated normally during the short journey of 10 minutes from Old Oak Common. When he was in the station Driver Tunnock found that he could not cancel the AWS. He therefore had to isolate the system in order to release the brakes. Driver Tunnock reported both faults to George Barnfield, the Operations Supervisor at Paddington. Mr Barnfield's duties included passing drivers fit for duty, which he did both in respect of Driver Tunnock and a little later, Driver Harrison. During the short time Driver Tunnock was in Mr Barnfield's office a phone call was made, the intention of which was to report the faults to the GWT Control office at Swindon. The result of this call is considered later.

AWS Isolation Switch with lead seal in place

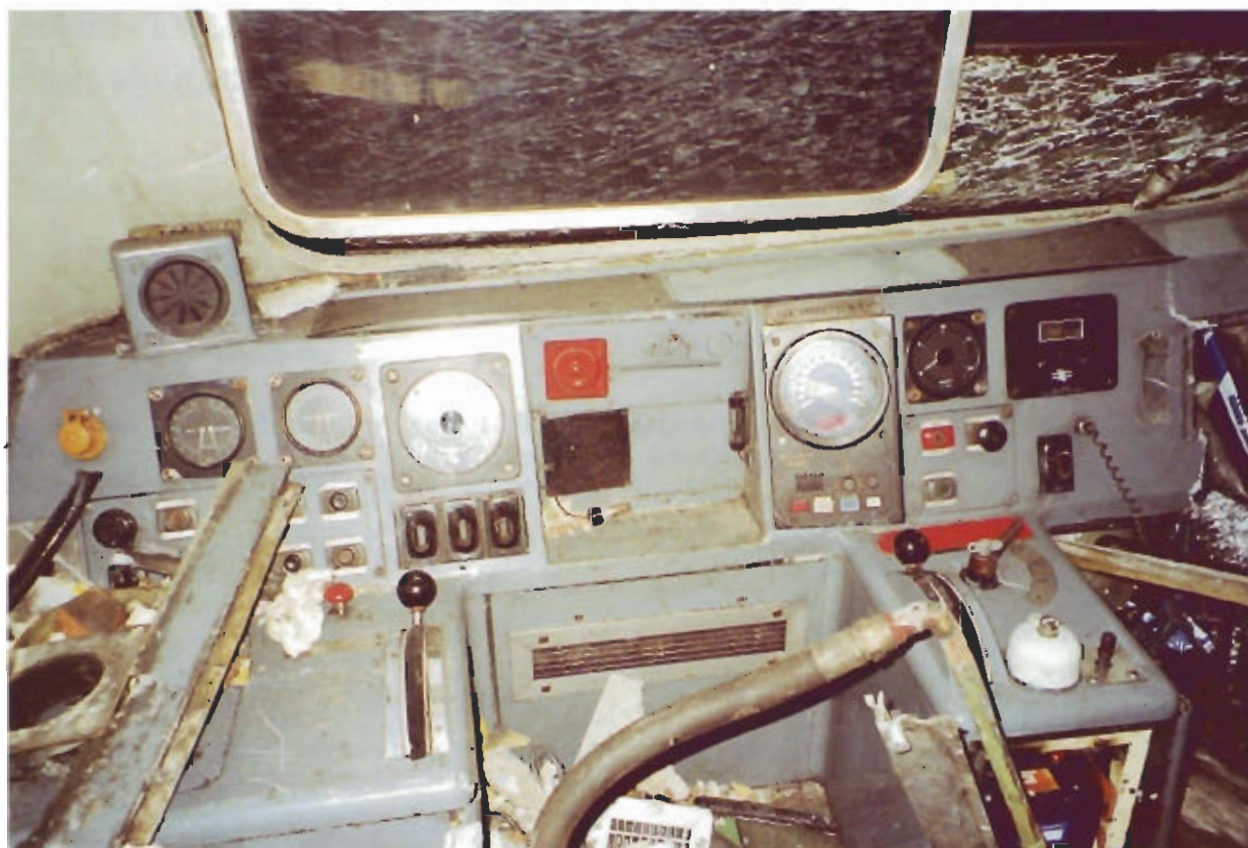
Driver's cab from Power Car 43173 Post Accident
