The Southall Rail Accident Inquiry Report

Professor John Uff QC FREng

Inquiry into Southall Railway Accident

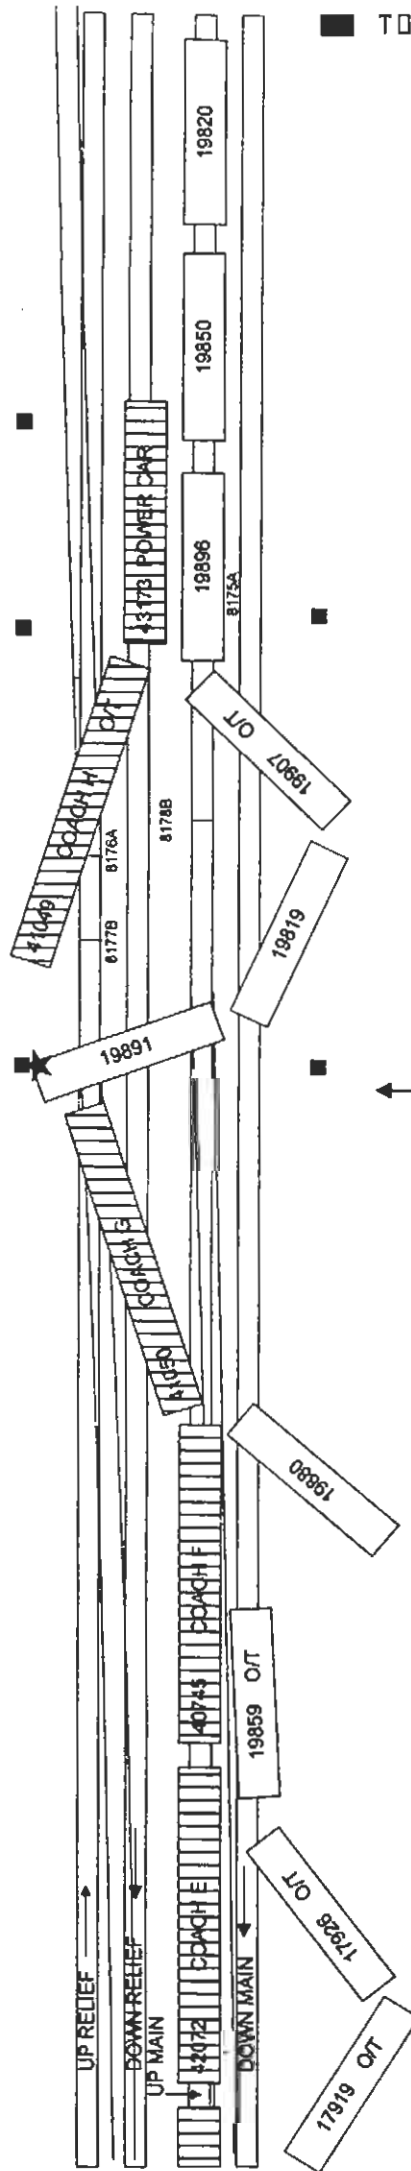
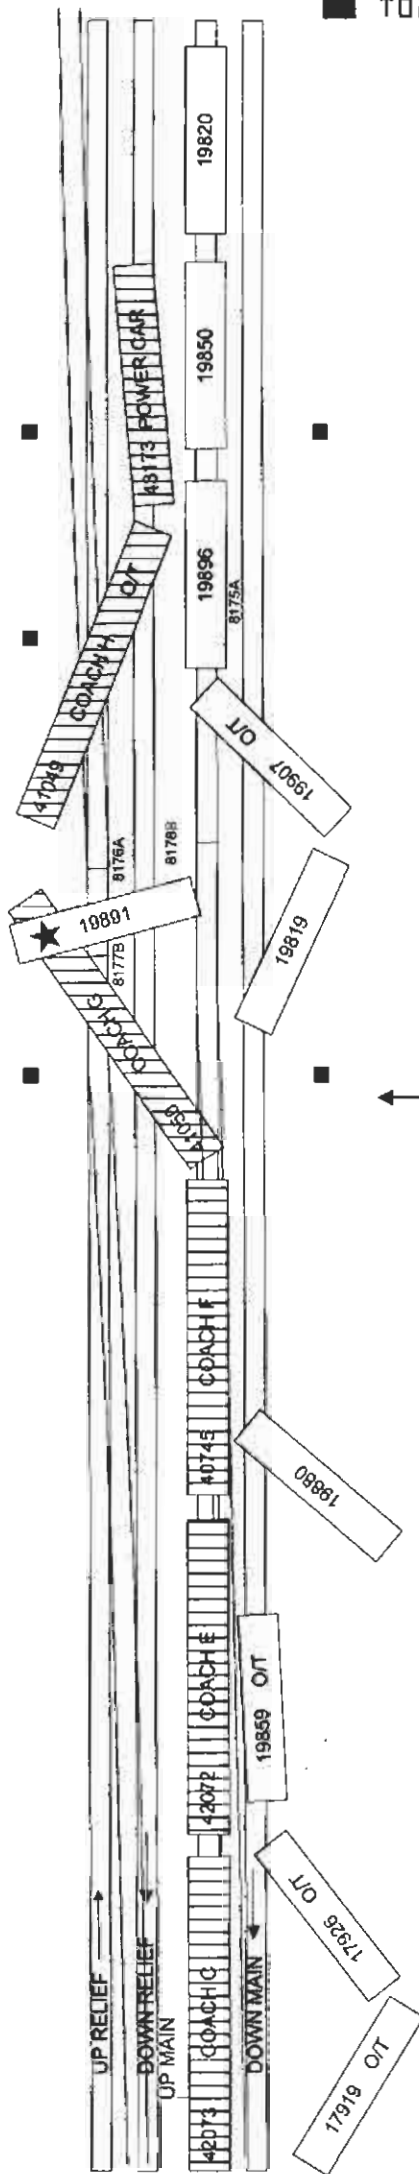
ANNEX 06C

Account of the reconstruction of collision events in the Southall rail crash

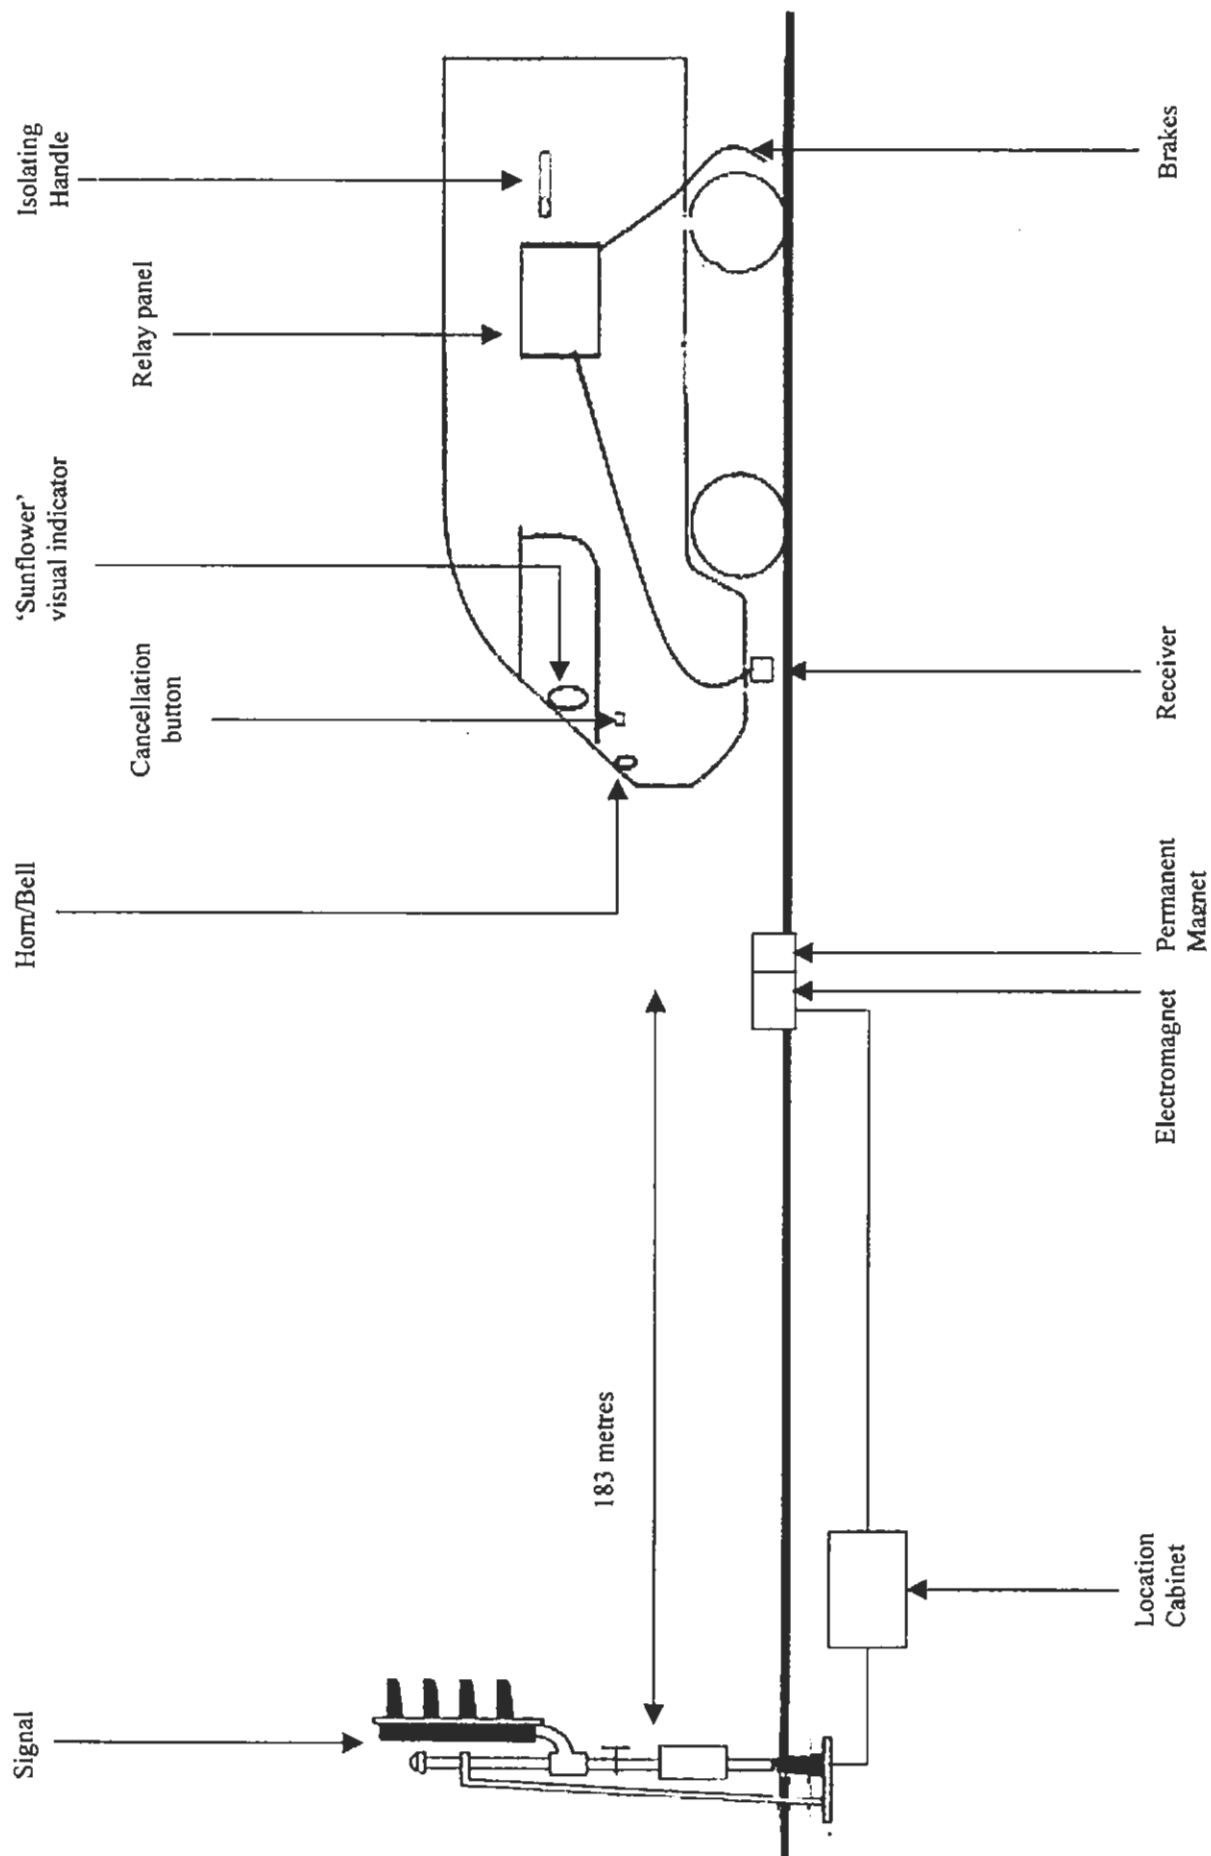
**ANALYSIS OF GWT AWS IN SERVICE ISOLATIONS OVER THE
PERIOD 01/01/97 TO 19/09/97 BY INDIVIDUAL EQUIPMENT**

EQUIPMENT	NUMBER OF FAULTS
RECEIVER	24
RELAY PANEL	04
WIRING	5
CONVERTER	04
RESET BUTTON	01
NO FAULT FOUND	45
TOTAL	83
